Historic Bridge Management Plan for the Grand Lake Pontoon Bridge

Recall Number: 033760

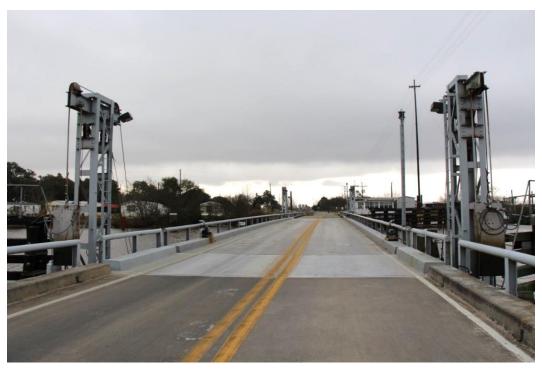
Condition Photo 1: Overview of pontoon swing span.

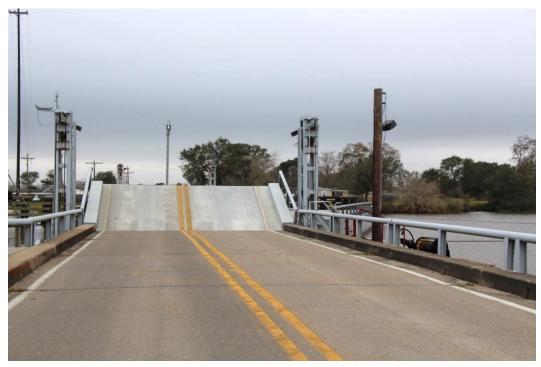
Condition Photo 2: Typical approach apron lift span showing steel plate rotated vertically.

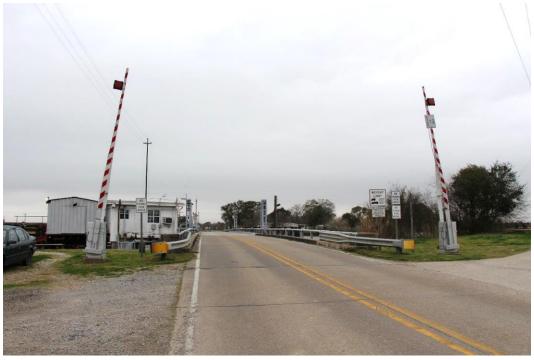
Condition Photo 3: Traffic warning gates and signals at the east approach roadway.

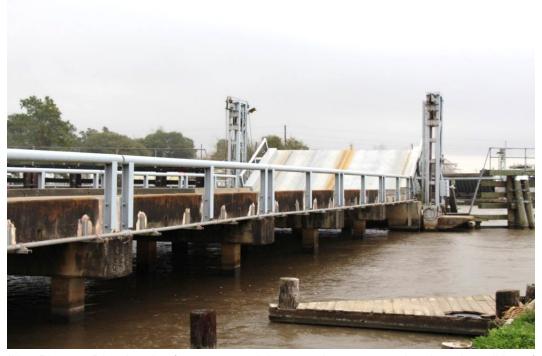
Condition Photo 4: Discoloration from water staining on substructure and curb and condition of steel railing (west approach spans shown).

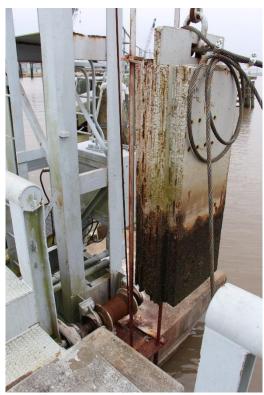
Condition Photo 5: Condition of approach apron lift tower. Rust, corrosion, and section loss on counterweight and counterweight guide bars typical for four counterweights.

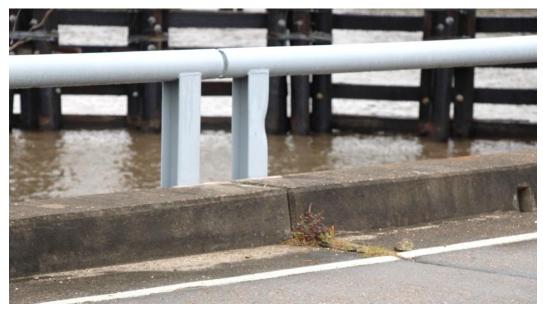
Condition Photo 6: Debris and vegetation on bridge deck, typical on approach spans. Photo also shows condition of railing.

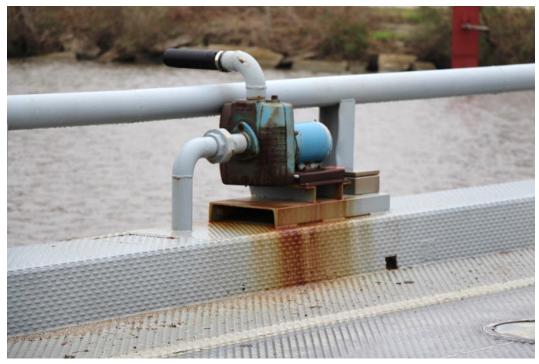
Condition Photo 7: Pontoon pump, one on each corner of pontoon span. The surface rust on the leveling pump and platform is typical for all four pumps.

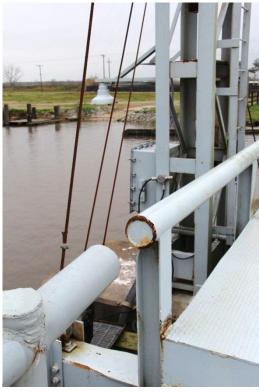
Condition Photo 8: Localized paint failure on steel pipe railing, typical throughout the bridge.

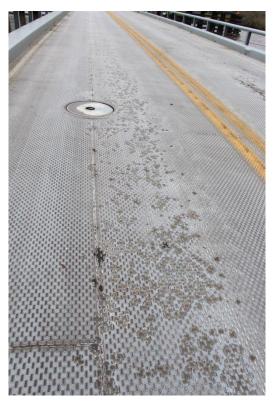
Condition Photo 9: Minor pitting in steel deck on eastbound traffic lane of the pontoon swing span.

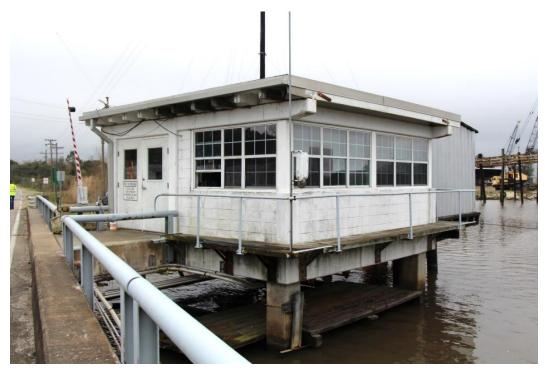
Condition Photo 10: Operator's house exterior condition, with hydraulic equipment shed in background.

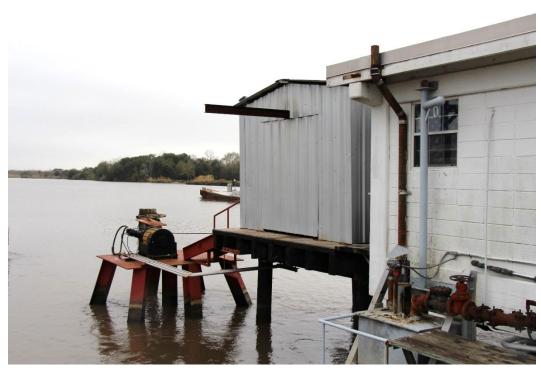
Condition Photo 11: Operator's house and hydraulic equipment shed exterior condition. Also note hydraulically operated winch mounted on pile supported platform.

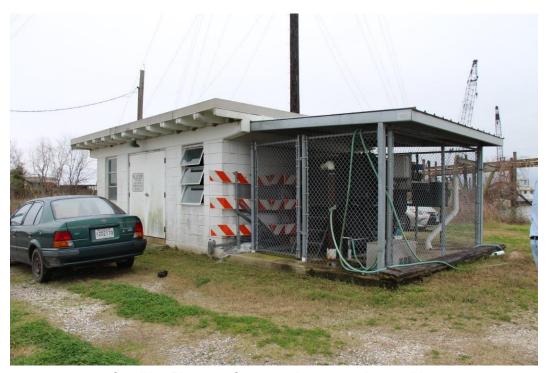
Condition Photo 12: Generator house exterior condition.

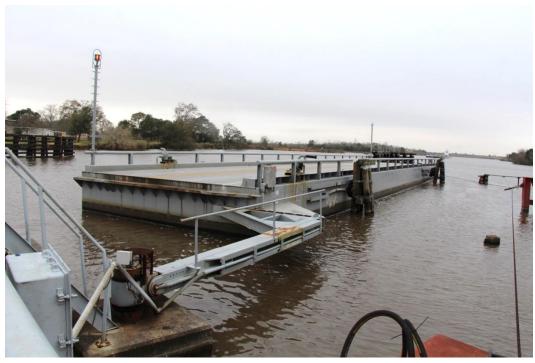
Condition Photo 13: Pontoon swing span in the open position showing pivot arm and support for the pivot arm.

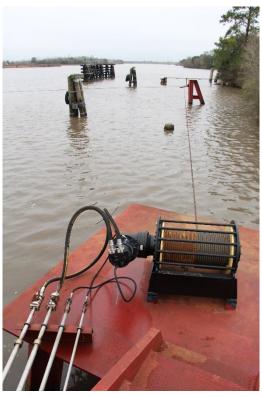
Condition Photo 14: Operating machinery, hydraulically operated winch and cable system, including foundation supports. Note: the winch has been replaced with a system that keeps the cables out of the water.

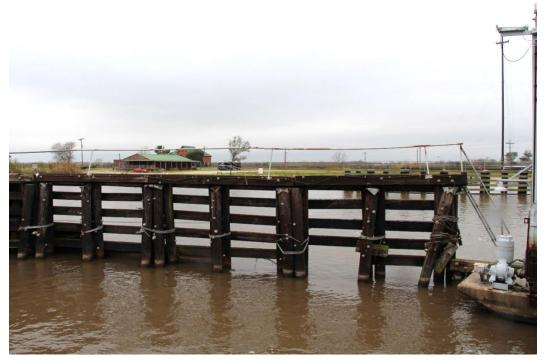
Condition Photo 15: Missing horizontal member and metal railing on southeast timber fender.
