Historic Bridge Management Plan for the Vermilion River Bridge at Abbeville

Recall Number: 009460

June 2017

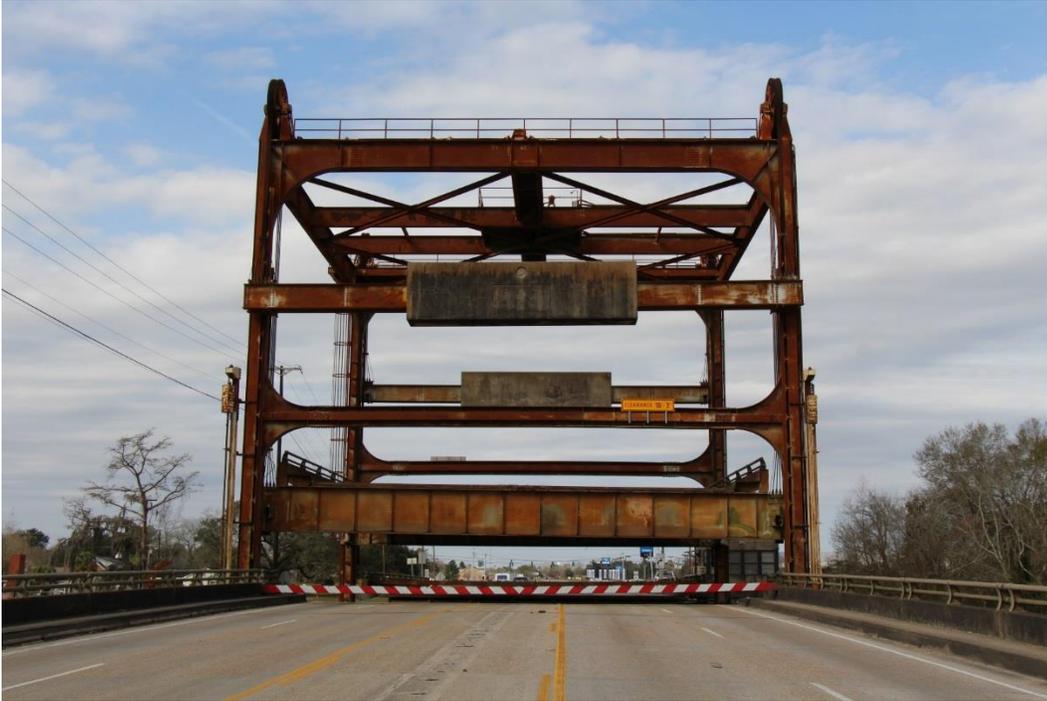
Condition Photo 3: Vertical lift span partially opened with traffic barrier railing down. Note the failure of the paint system on components of the lift span.

2. Clean and paint the steel I-beams for spans 4 and 6, in accordance with the current standard cleaning and painting specification.
3. Repair or replace deteriorated structural steel components on lift span and towers.

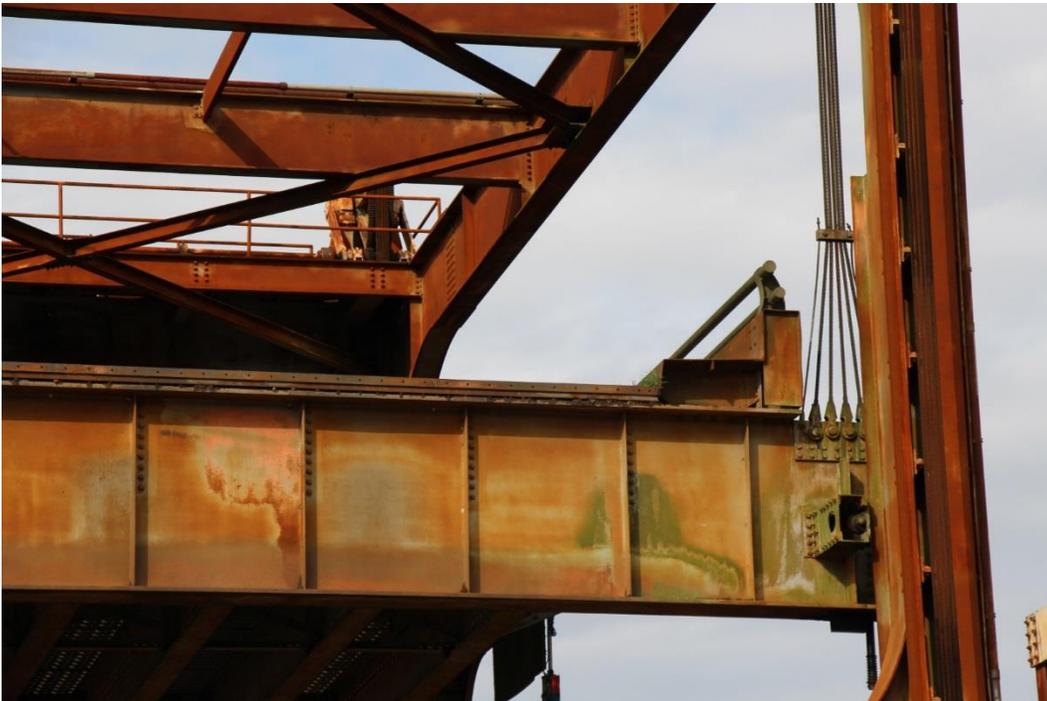
Condition Photo 4: Vertical lift span at lift girder, showing failed paint system as well as the condition of the wire ropes that attach to the lift girder and the condition of the guide tower.

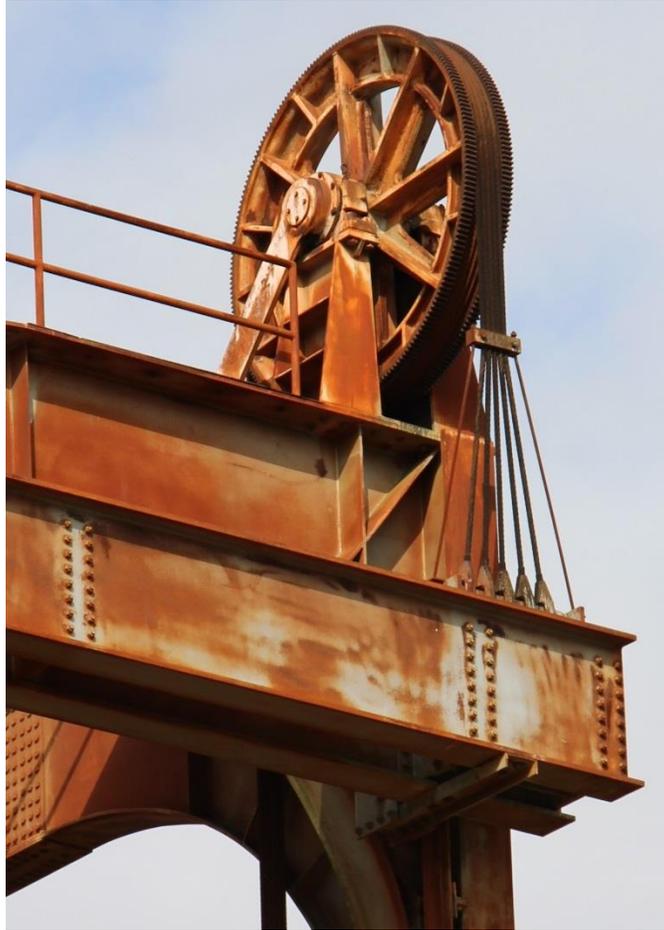
Condition Photo 5: Sheave and wire ropes on the corner of the vertical lift span.

4. Perform non-destructive testing (NDT) on the cracks on the floorbeams and retrofit the cracked welds or arrest the cracks by drilling holes.
5. Clean, paint, lubricate, and adjust the exposed operating machinery, including sheaves, shafts, speed reducers, bearings, and motors.

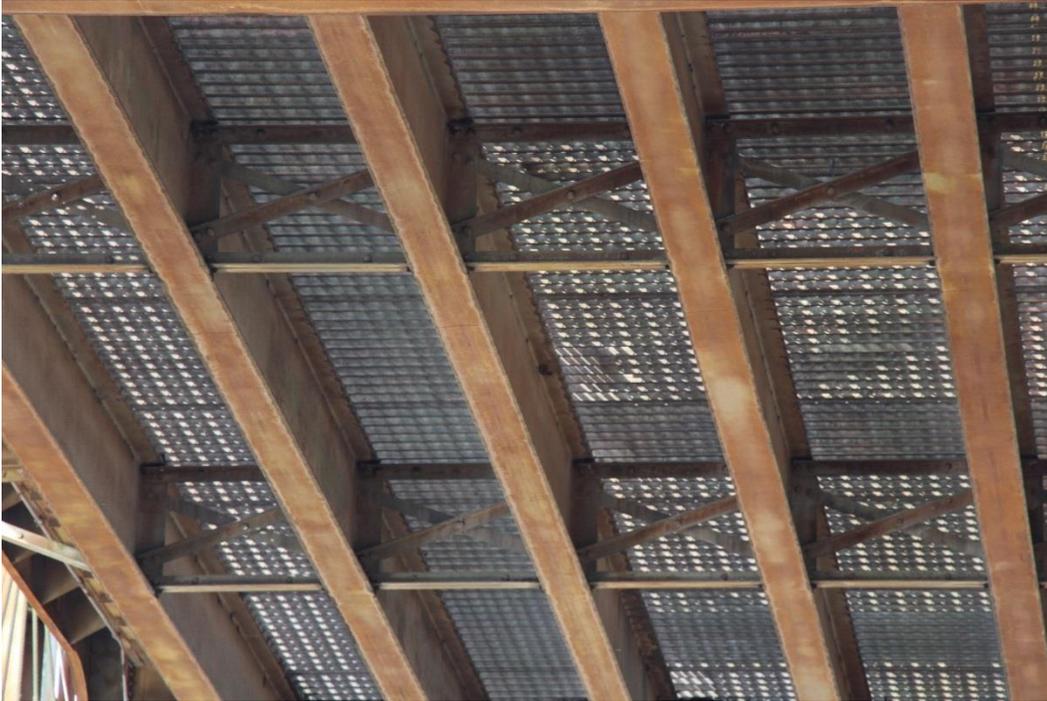
Condition Photo 7: Stringers and cross bracings of the vertical lift span showing failed paint system. The photo also shows the condition of the underside of the metal grid deck.

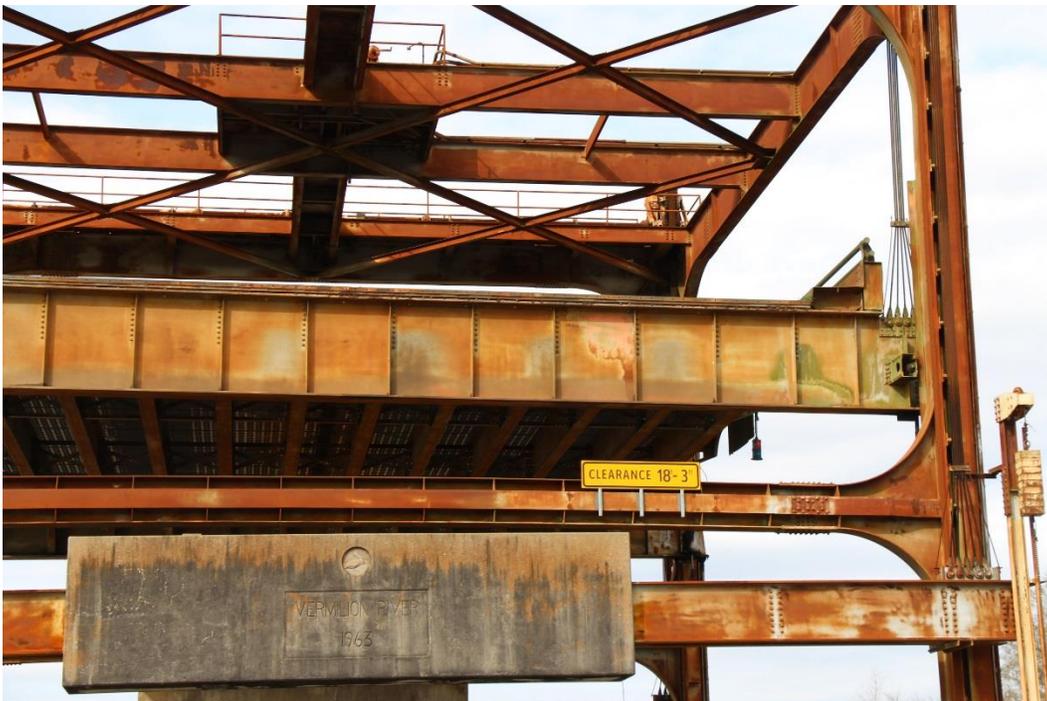
Condition Photo 8: Condition of longitudinal steel stringers framing into the end lift girder.

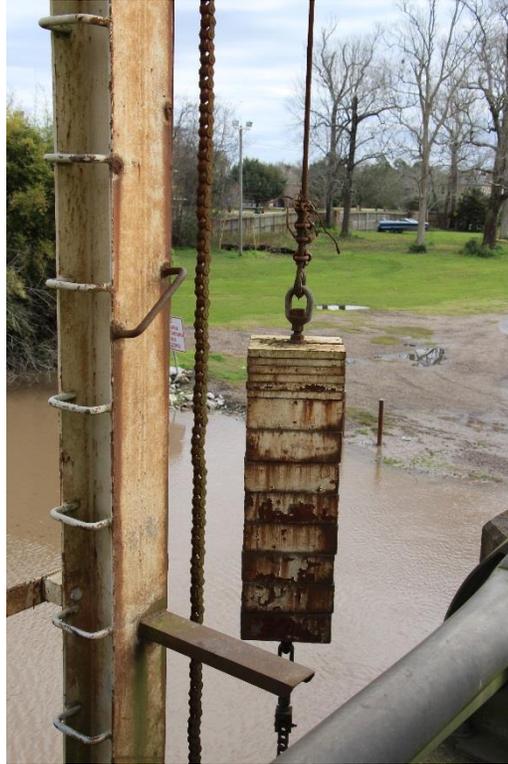
Condition Photo 9: Corrosion and paint failure on the counterweight and tower for the traffic barrier railing, typical for four towers and counterweights.

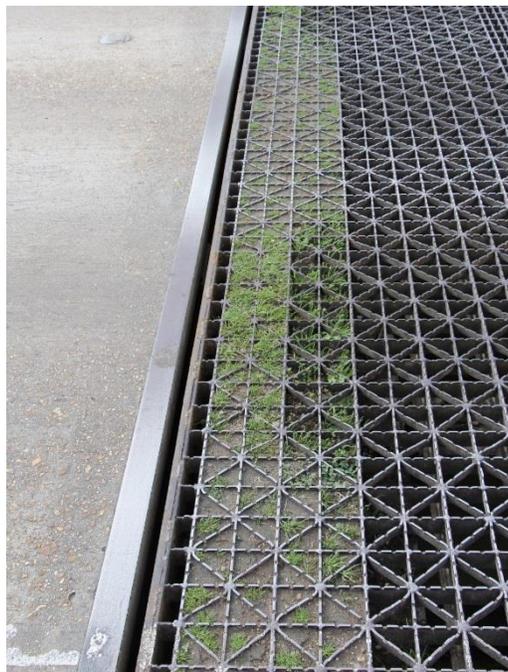
Condition Photo 10: Open grid steel deck filled with dirt and vegetation growth at joint between lift span and approach span.

1. Clean out debris in open steel grid deck and sidewalks on the lift span regularly. Clean debris from the open deck joints, sidewalks, and concrete slab bridge deck on approach spans regularly to maintain good condition.
2. Repair broken or loose metal grid deck bars regularly to maintain good condition, as necessary.

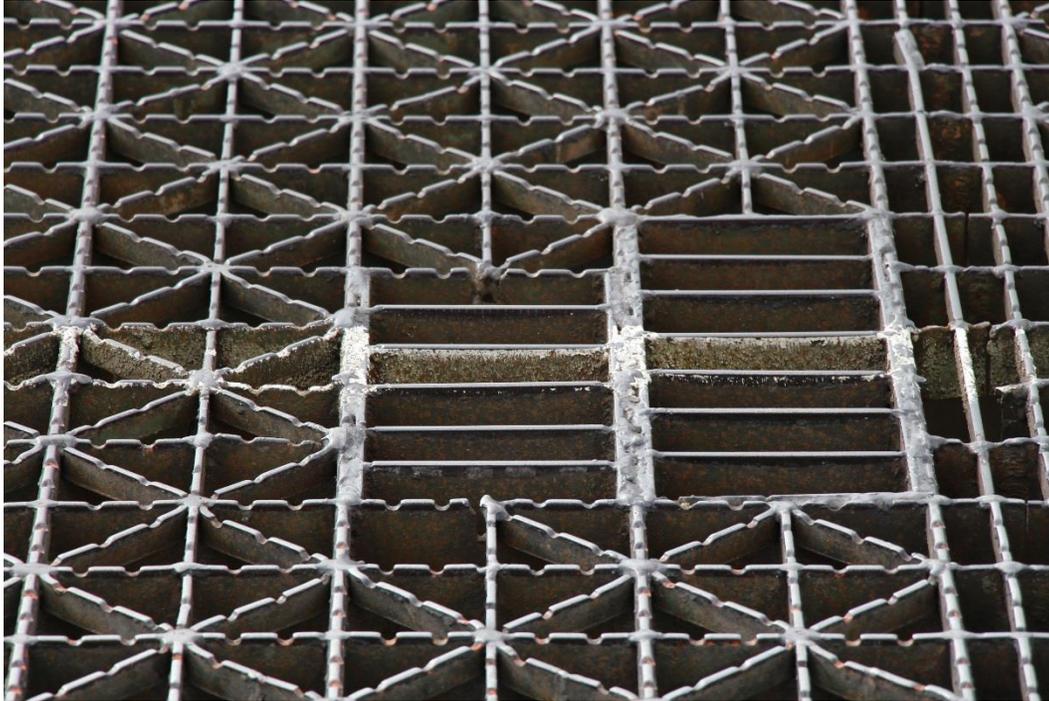
Condition Photo 11: Open grid steel deck showing repaired areas.

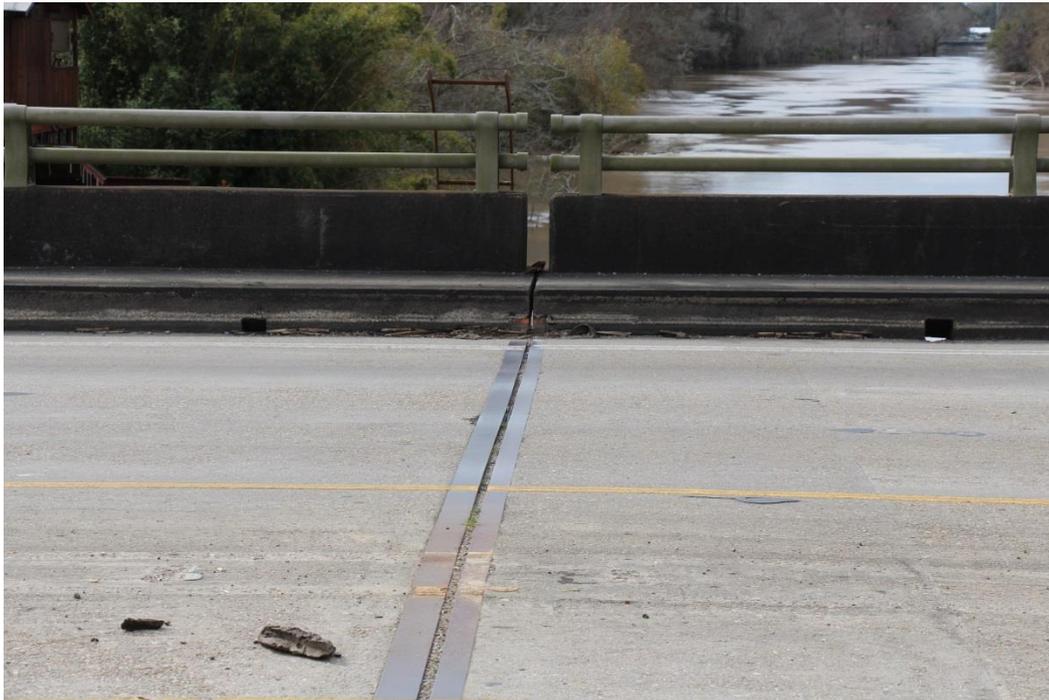
The expansion joints between spans 3 and 4 and spans 6 and 7 are in fair condition. The joint material is torn and the joints are full of debris, although the steel angles at the joints are in good condition. The concrete substructure units (piers and bents) are in good condition. The pier caps exhibit typical water staining from the open deck joints above. The bent 5 cap is exhibiting minor spalling and cracking, and hairline cracks are present within 1 foot of the cap. Pile 7 on bent 5 is spalled.

Condition Photo 12: Expansion joint in deck of approach spans filled with debris.

6. Remove and replace expansion joint material in concrete roadway decks for approach spans.
7. Clean the operator house and inside (roadway side) of the concrete railings across the entire bridge and substructure concrete units to remove water staining discoloration and algae growth with low-pressure water spray.

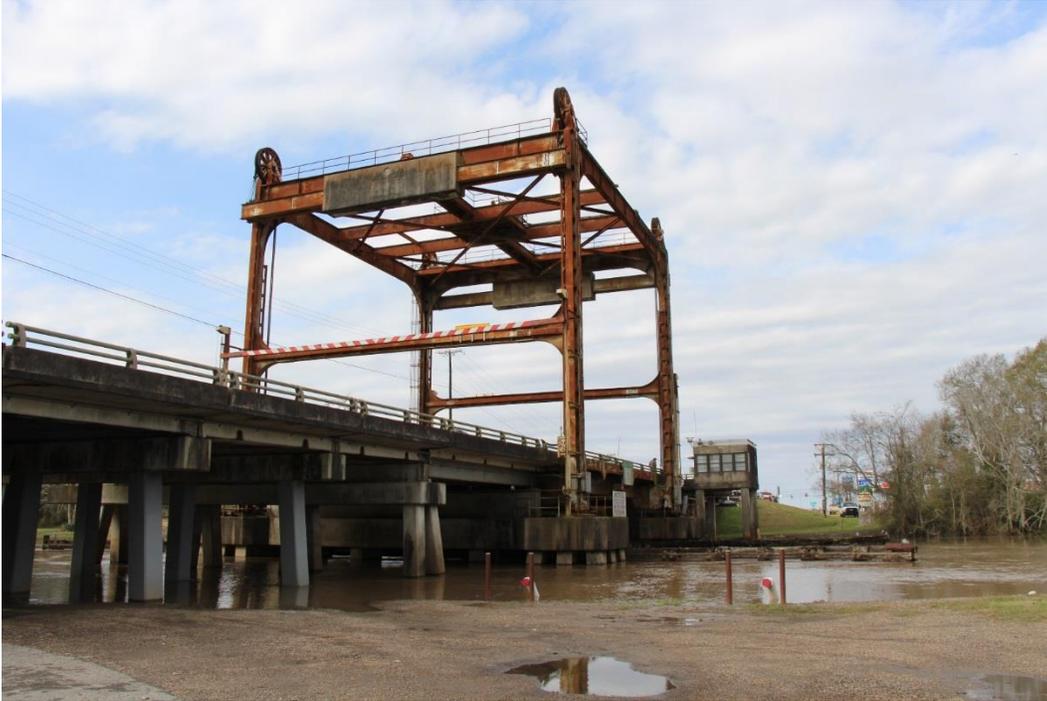
Condition Photo 13: Overview of vertical lift span showing water staining on the substructure units and the concrete piles, several of which are surface-coated.

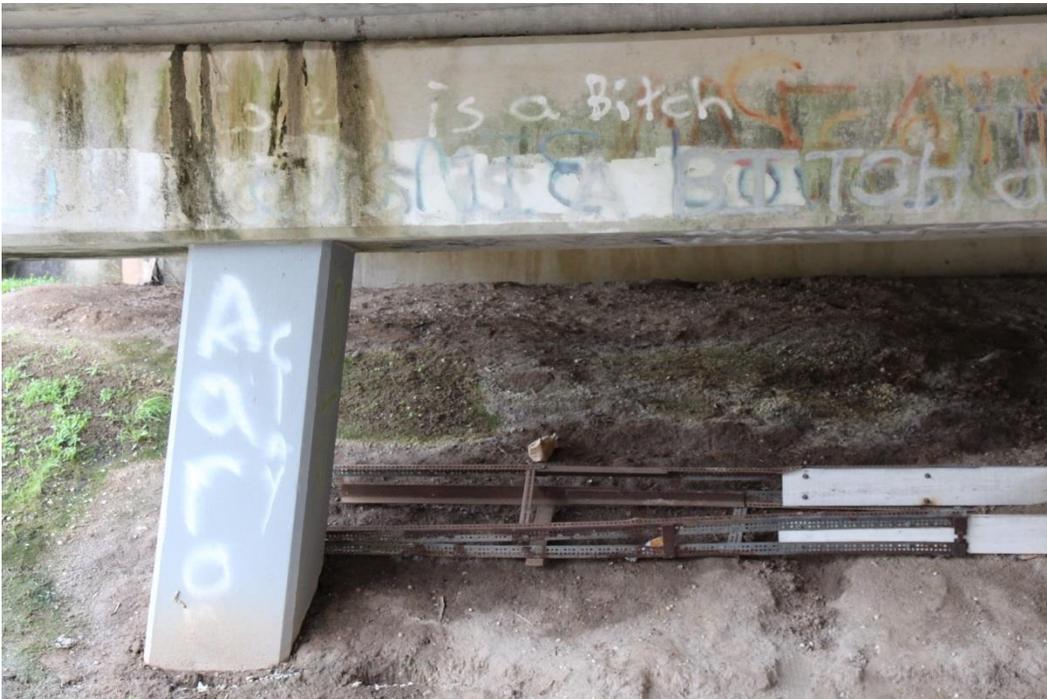
Condition Photo 14: Bent 2, concrete bent cap, and pile columns showing graffiti, water staining, and coating.

3. Remove and replace decayed timber components of the fender protection system regularly to maintain good condition.
4. Remove debris built up around concrete piles at the bents regularly to maintain good condition.
5. Recoat or paint over graffiti on concrete substructure units with a coating that matches the color, consistency, and texture of the existing coating, as needed. The recoating should be limited to the area of graffiti only, and this practice to cover graffiti should not be done elsewhere on the bridge.

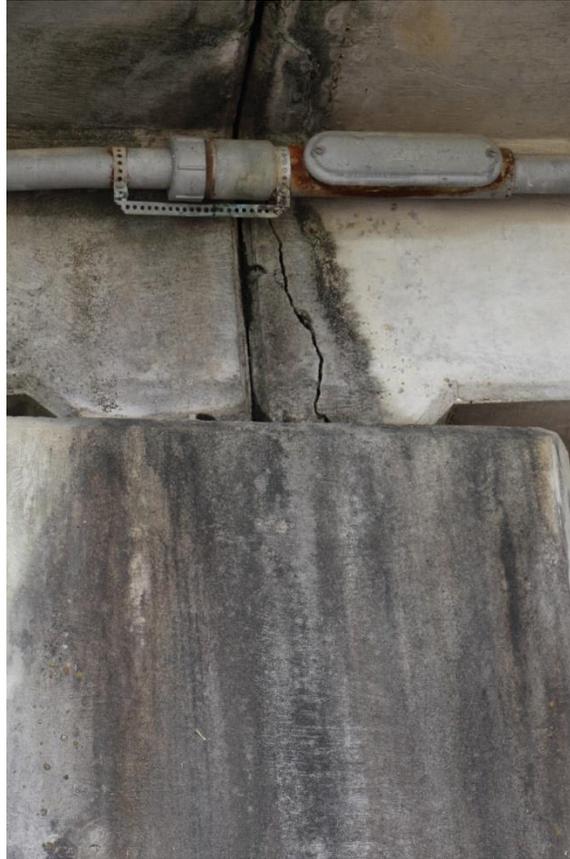
Condition Photo 15: Cracking of the concrete slab haunch at the concrete bent cap. Also note condition of expansion joint in metal conduit for electrical cable.

8. Repair the exterior screen door of the operator house and clean and paint the inside entrance door.
9. Repair spalls and cracks in the concrete substructure units.

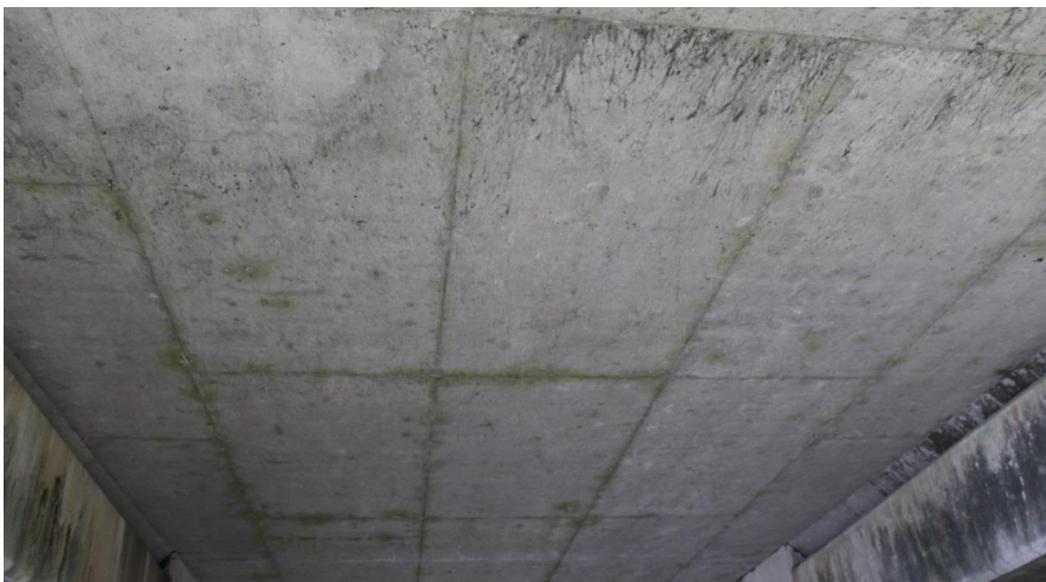
Condition Photo 16: Cracking and efflorescence of the underside of the cast-in-place concrete approach spans.

10. Repair spalls and cracks in the concrete deck, railing, and sidewalks.

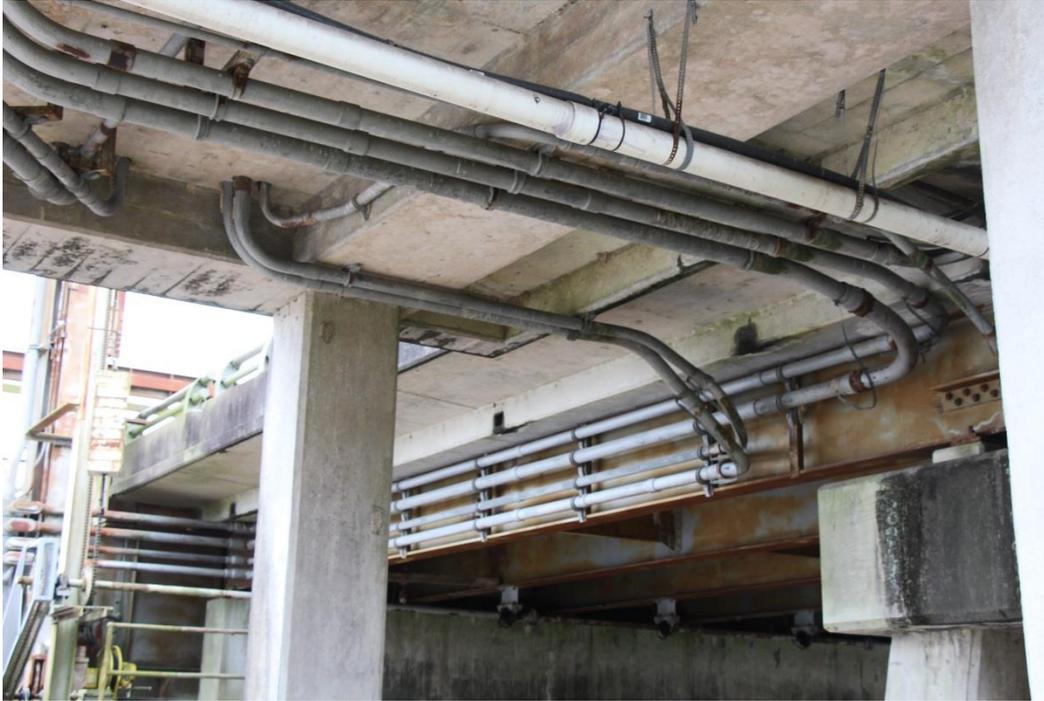
Condition Photo 17: Paint system failure on the steel approach spans.

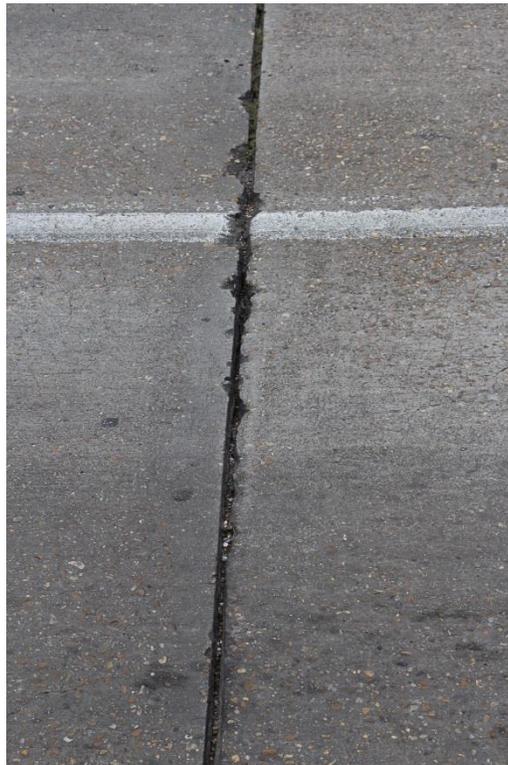
Condition Photo 18: Concrete spalling along relief joint on approach span.

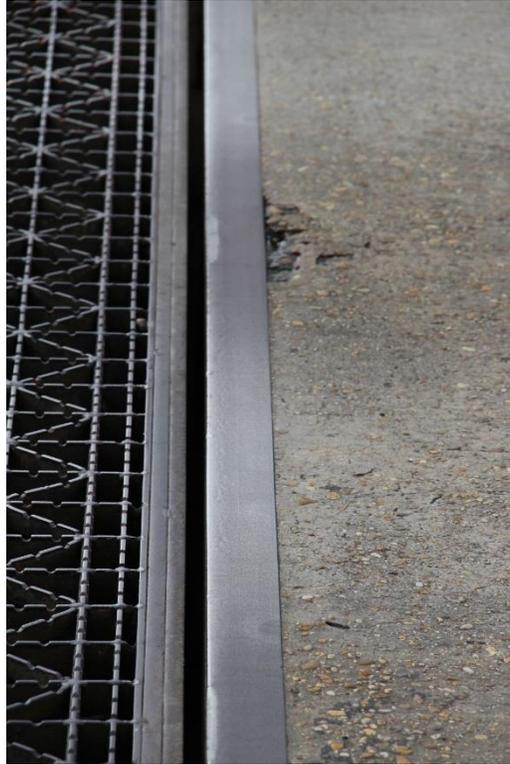
Condition Photo 19: Spalled concrete at an open joint between the lift span and the approach span.

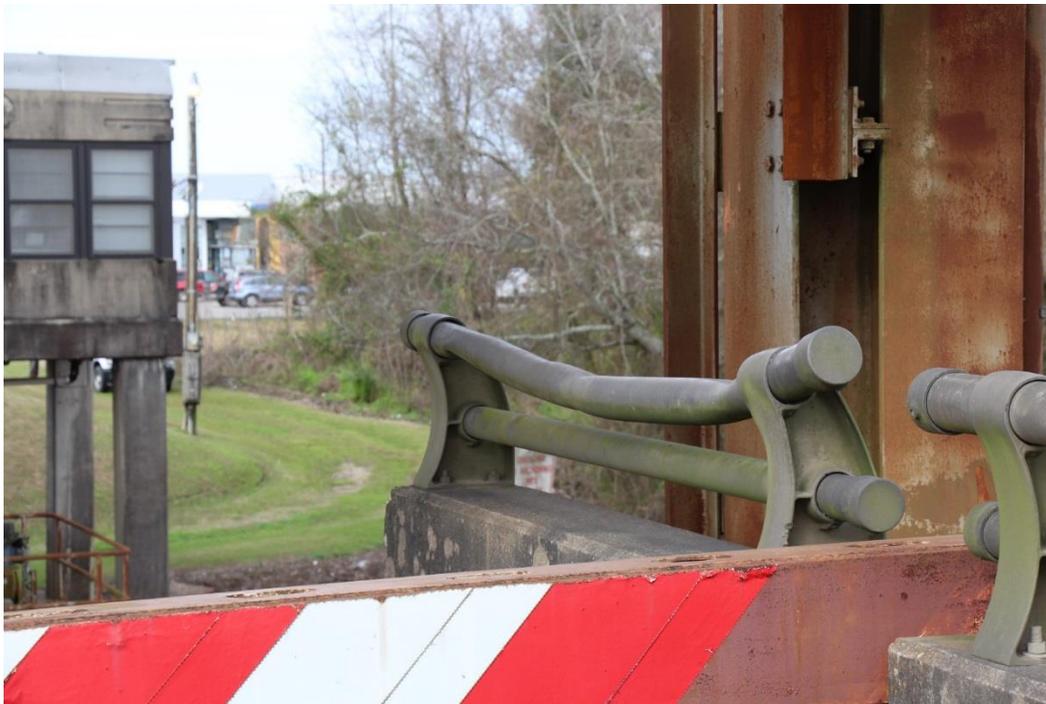
Condition Photo 20: Damaged aluminum tube railing at lift tower in northwest corner of lift span.

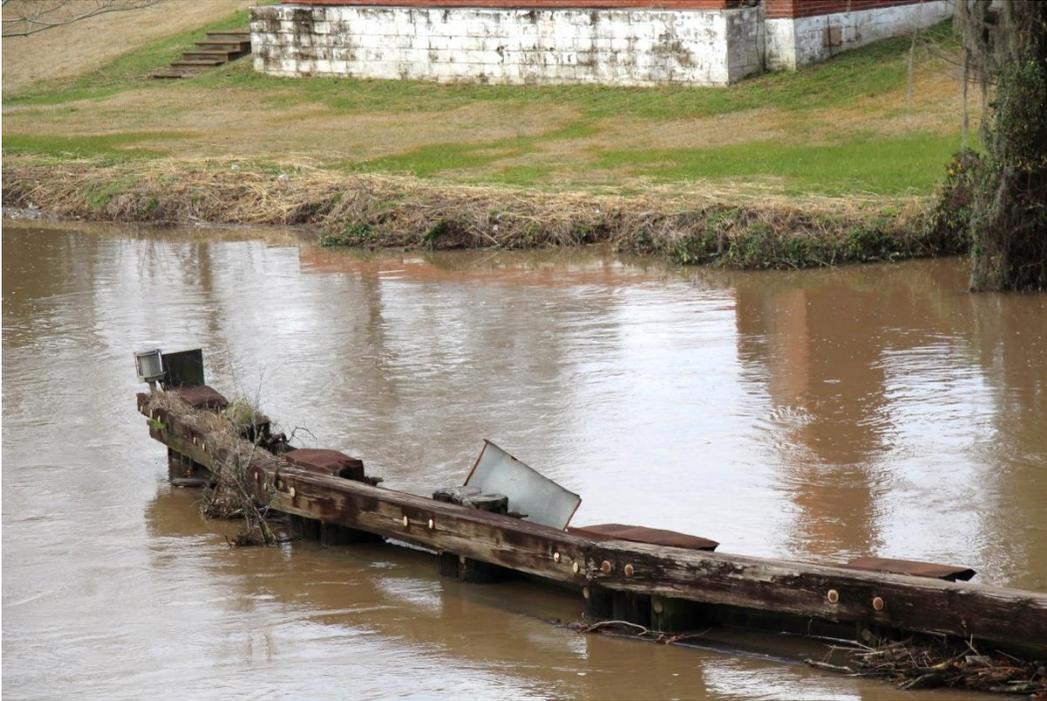
The timber fender system is in fair condition with decay and vegetation growth throughout. The fender system has been maintained to provide its function of protecting the bridge from impact loading from river navigation traffic.

Condition Photo 21: Decay and heavy vegetation growth and debris in timber fender system.

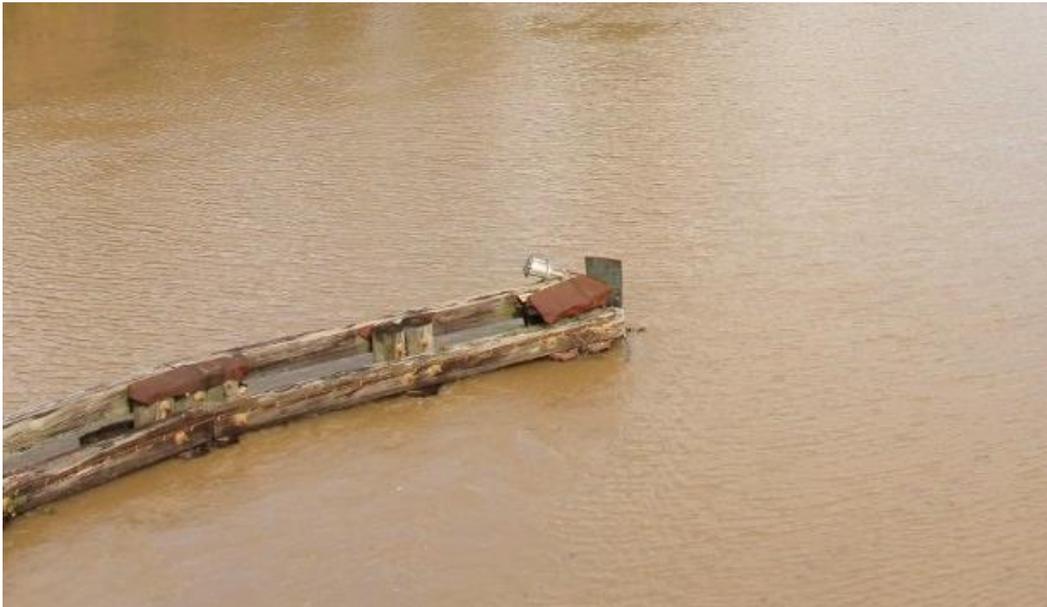
The navigation lights are in fair condition. Three of the six lights attached to the timber fender system are bent and only one of the six lights is working. The navigation lights attached to the underside of the concrete barrier railing in the main vertical lift span, both upstream and downstream, are working.

Condition Photo 22: Bent navigation light at the end of the timber fender system.

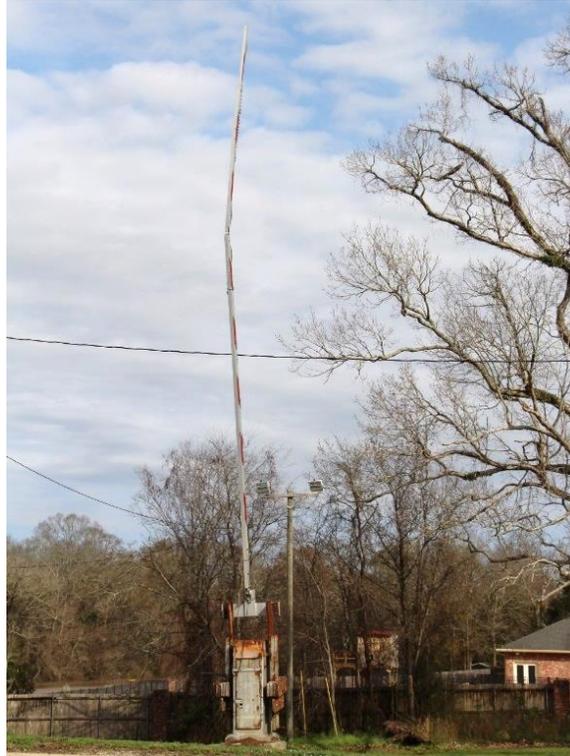
Steel traffic barrier gates and their supporting towers on each side of the vertical lift span are lowered when opened, and are in good functional and structural condition. When the vertical lift span is opened, traffic signals are used and traffic warning gates are lowered. The traffic warning gate on the east side of the bridge has a door hinge broken and the metal arm is bent. The traffic signals are functioning properly.

Condition Photo 23: Bent traffic warning gate arm and paint system failure.
