Historic Bridge Management Plan for the Vermilion River Bridge at Abbeville

Recall Number: 009460

June 2017

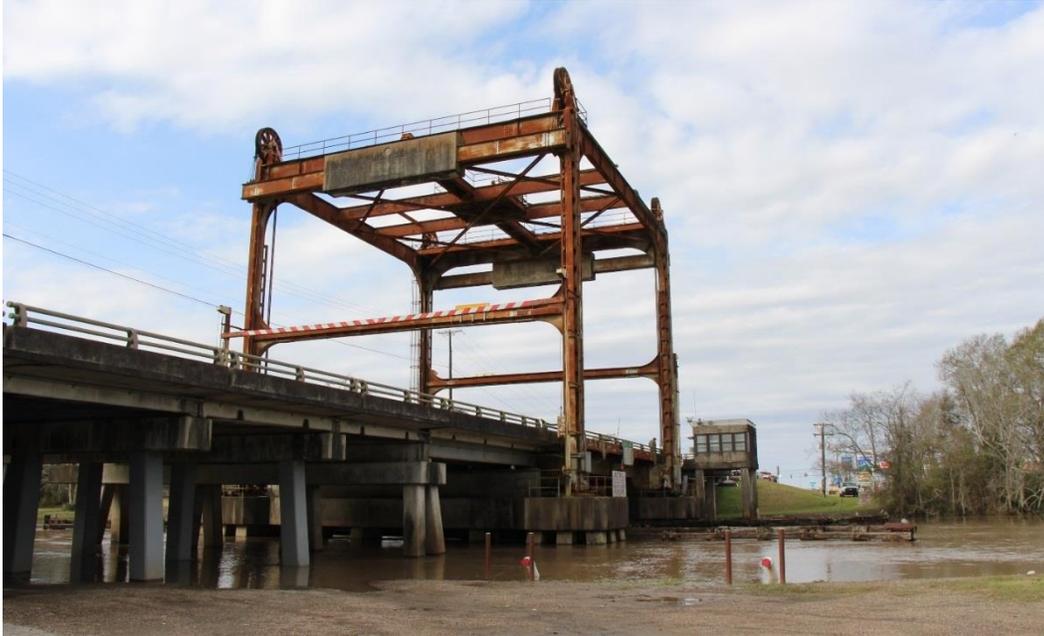
Character-defining Feature Photo 1: Design and construction of a vertical lift span with central drive machinery. The operating machinery, located at the center of a platform, drives the four sheaves on each corner of the lift towers. Note the location of the operator's house on the northwest quadrant of bridge, which is part of the historic fabric, not a character-defining feature.

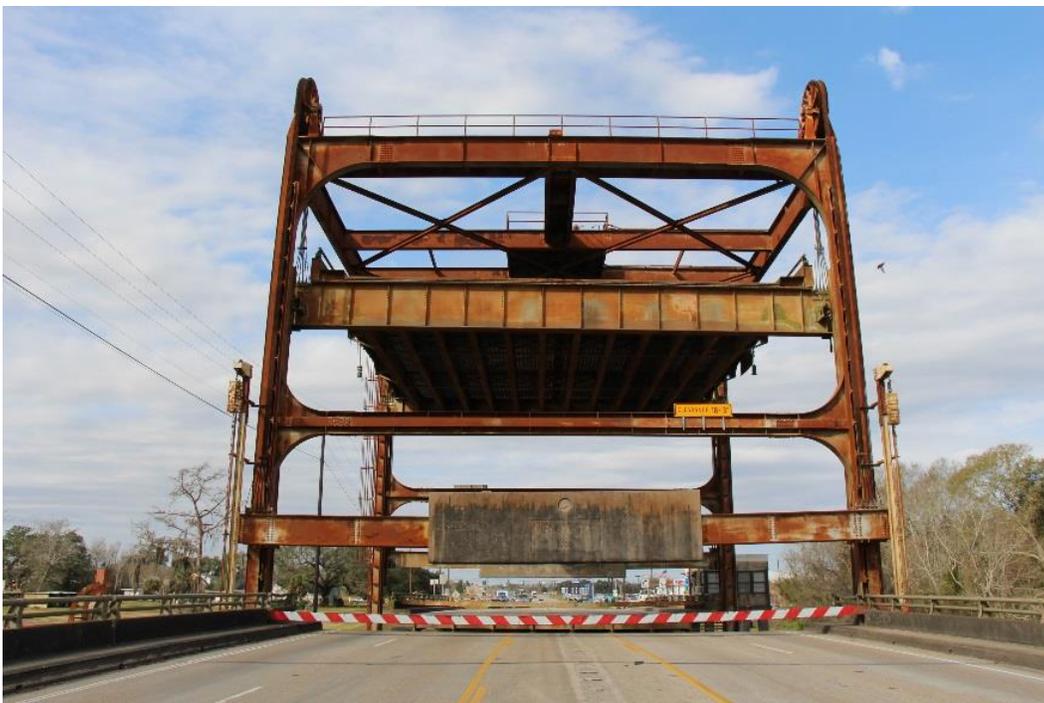
Character-defining Feature Photo 2: Vertical lift span with central drive machinery, with the movable span open, with steel barrier gates and concrete counterweights lowered.

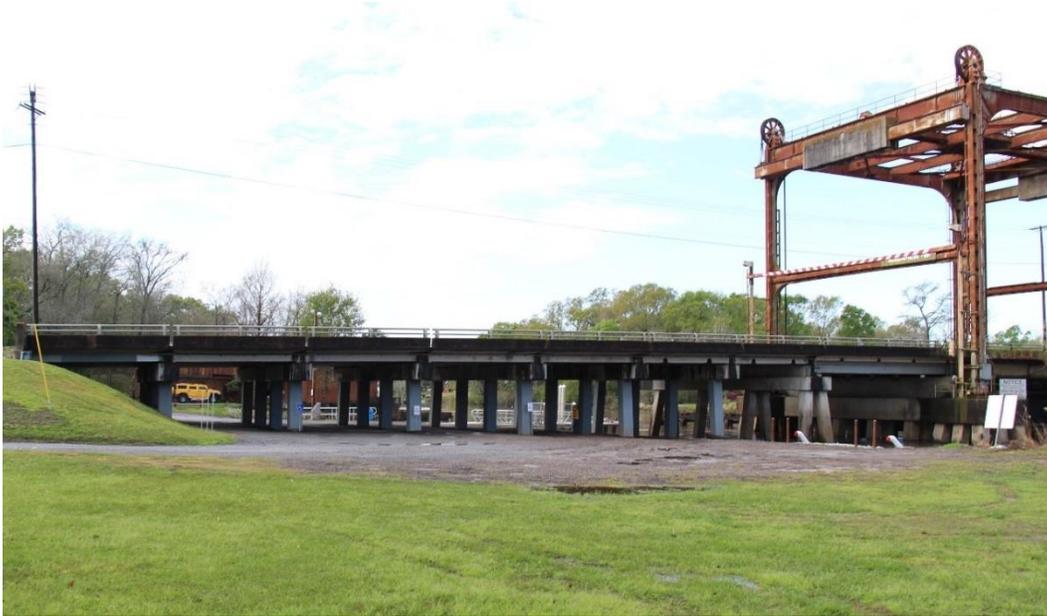
Historic Fabric Photo 1: Approach spans on the northeast side of the bridge, including the cast-in-place concrete slabs and steel I-beam spans supported on concrete piers and abutment. The photo also shows the steel traffic barrier gate and supporting towers adjacent to the lift span.

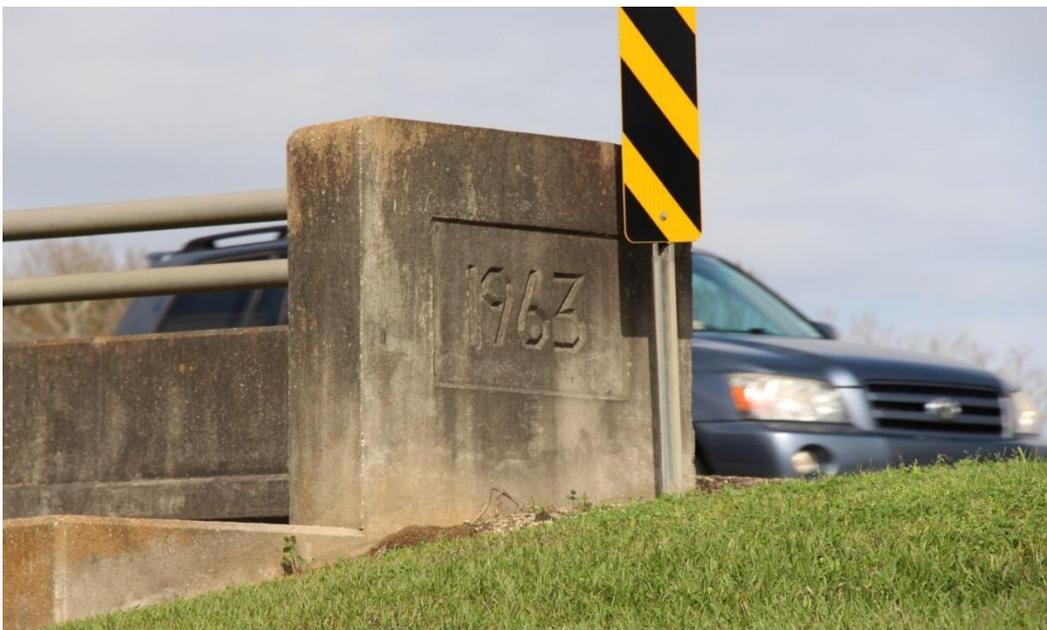
Historic Fabric Photo 2: Detail of endpost and concrete barrier and aluminum tube railing on approach spans.

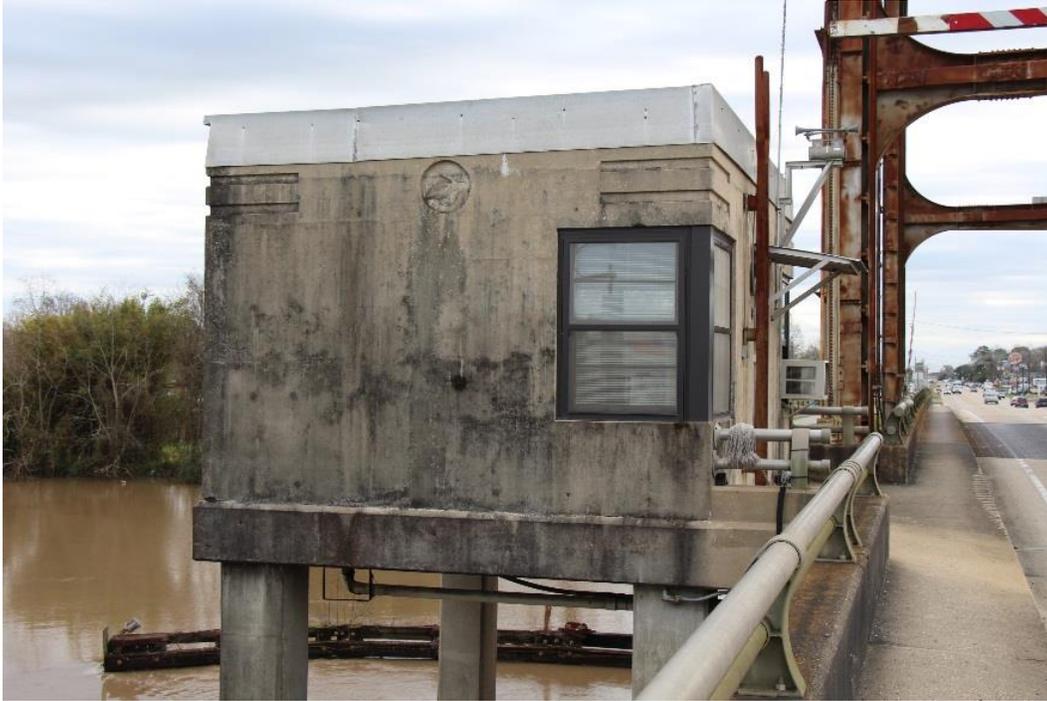
Historic Fabric Photo 3: Bridge operator's house.

The operator's house is in good condition and fully functional. The exterior concrete surface is discolored. The metal door is original and is exhibiting some rust and corrosion and the screen on the screen door is in poor condition. The floor is original and in good condition. The windows have been replaced and are in good condition. The control panel for the operation of the bridge is original and fully functional.

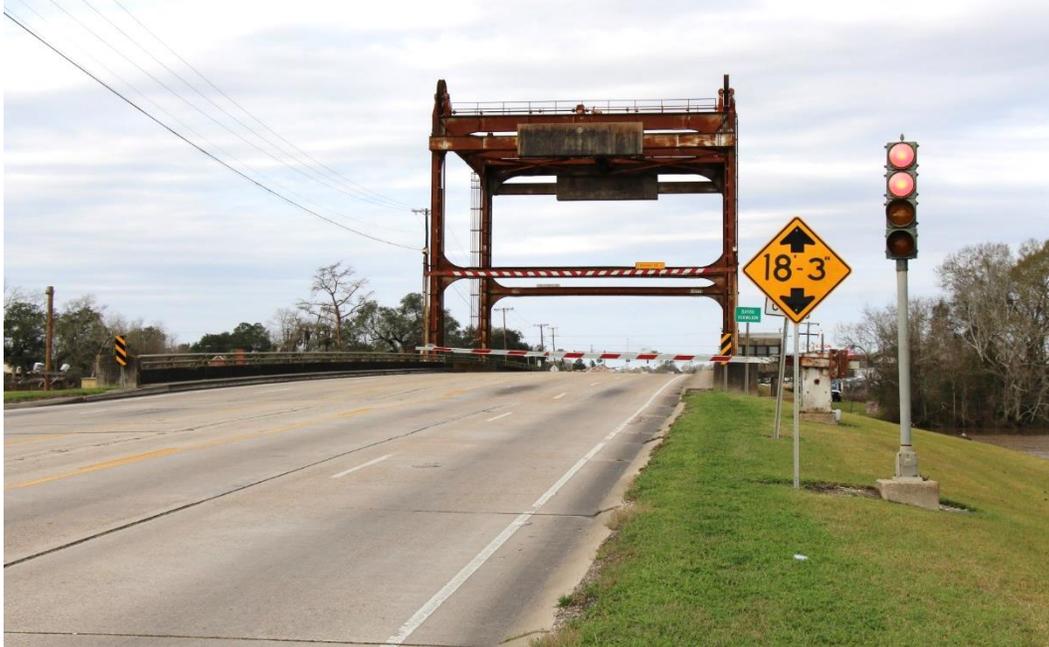
Condition Photo 1: Overview of the vertical lift span and roadway looking west from the east roadway approach to the bridge.

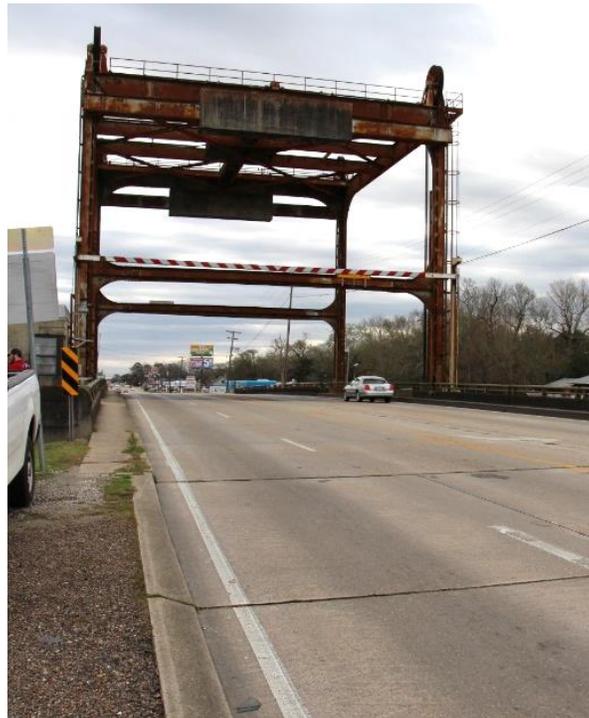
Condition Photo 2: Overview of the vertical lift span and roadway looking east from the west roadway approach to the bridge.

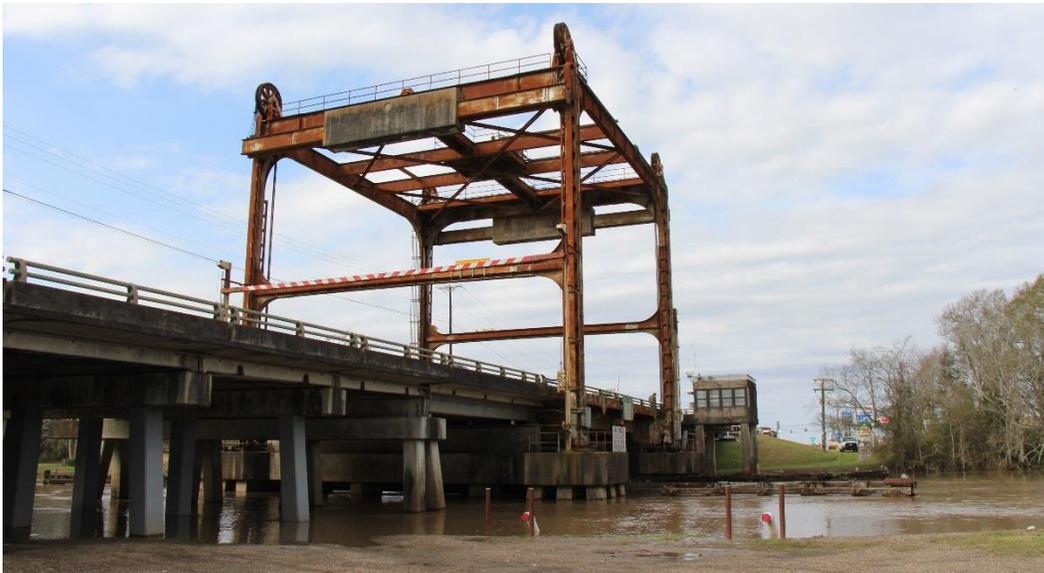
Condition Photo 6: Center platform of bridge supporting the operating machinery.
